**OLD GRIST MILL POND DAM
MA 00668**

PHASE I INSPECTION REPORT NATIONAL DAM INSPECTION PROGRAM

OCTOBER 1978

Identification No.: MA00668

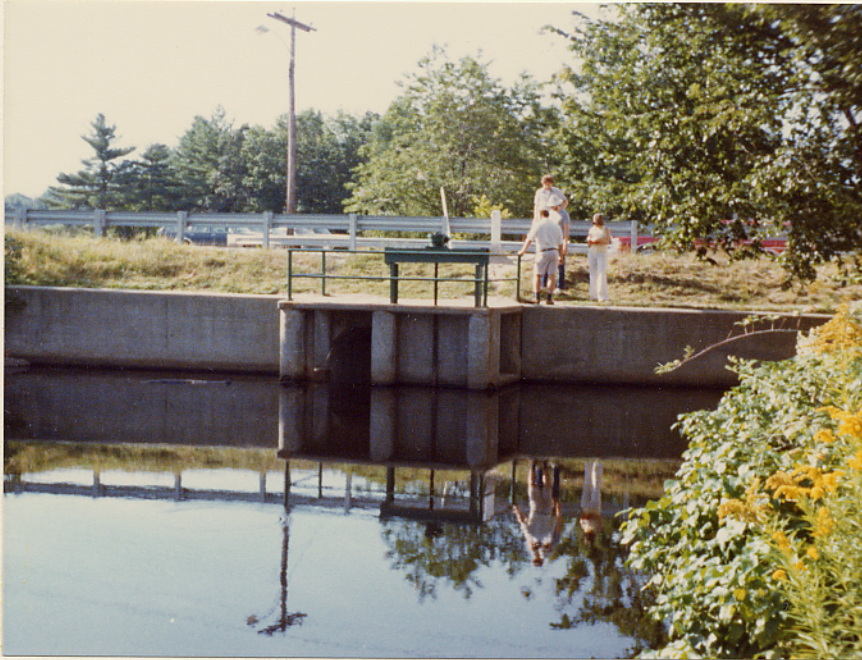
VIEW OF UPSTREAM FACE OF DAM

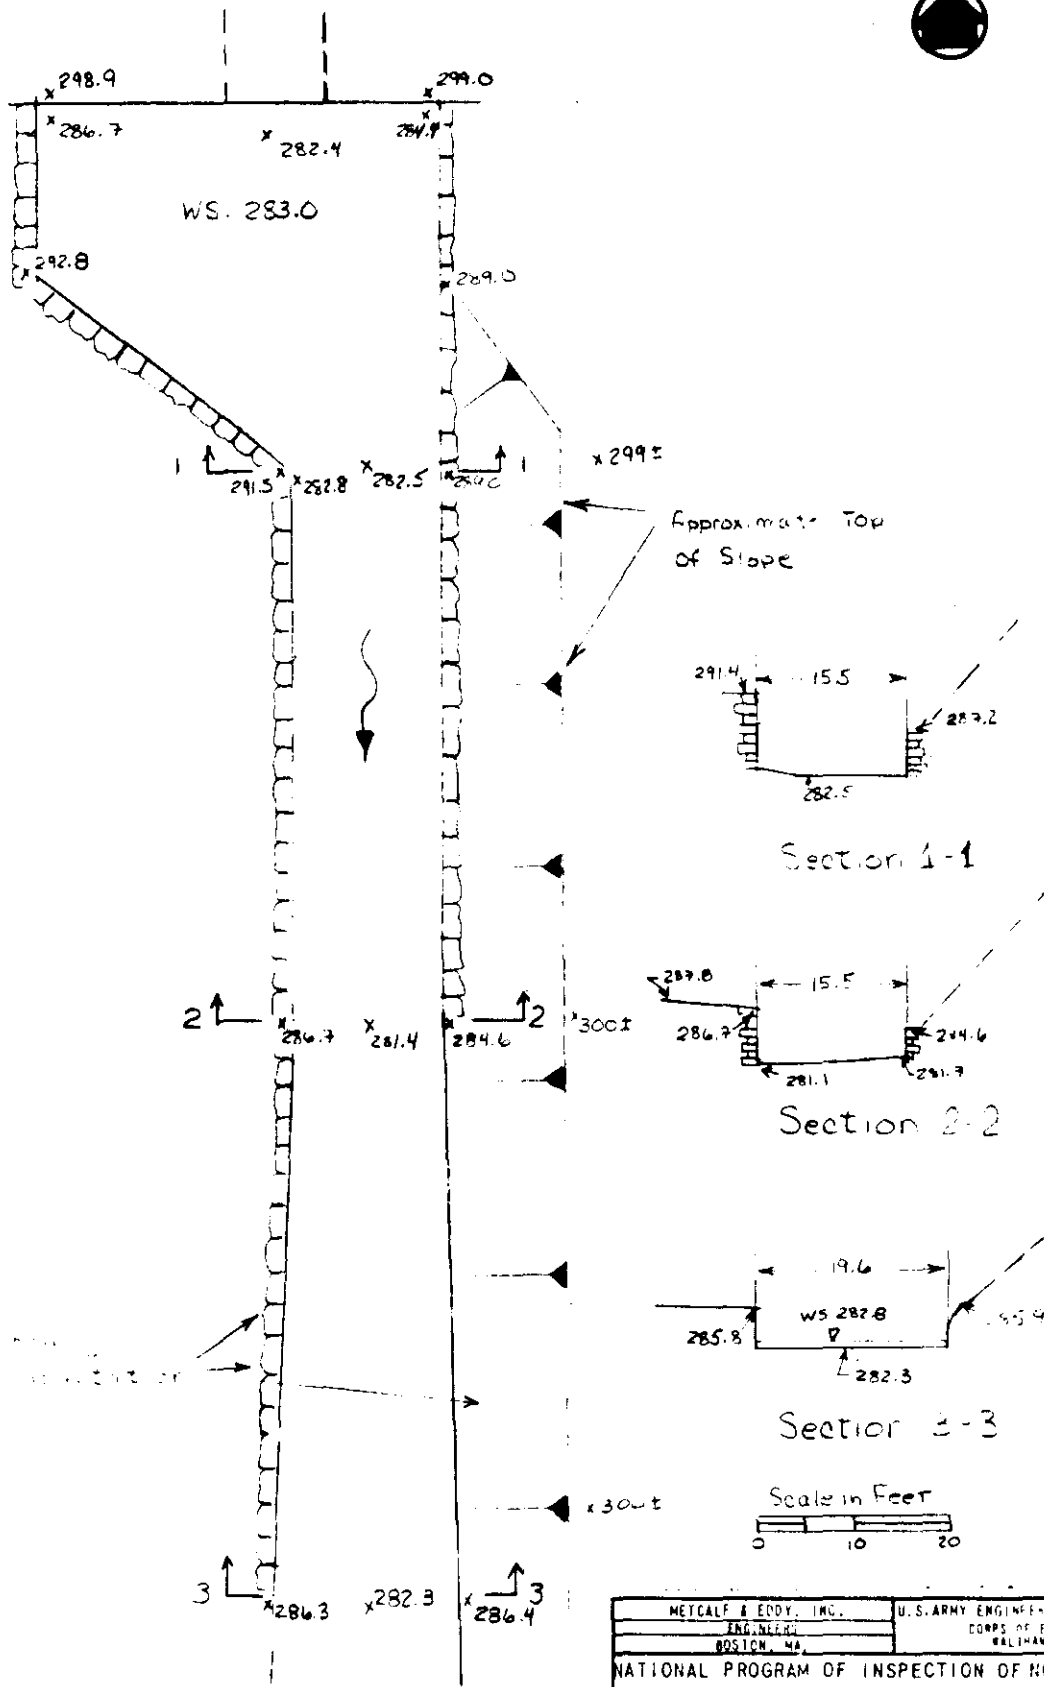
METCALF & EDDY, INC.	U.S. ARMY ENGINEER CORPS
ENGINEERS	CORPS OF ENGINEERS
BOSTON, MA	WALHAM, MA
NATIONAL PROGRAM OF INSPECTION OF NON FED DAMS	
OLD GRIST MILL POND DAM	
FIGURE B-2	
PLAN OF DOWNSTREAM CHANNEL AND SECTIONS	
TRIBUTARY BLACKSTONE RIVER	MASSACHUSETTS
SCALE: 1" = 20'	DATE: OCTOBER, 1978

The stream bed below the box culvert is thickly overgrown and in poor condition. The stonework in the sidewalls is deteriorating, and blocks of rock are overhanging and falling into the channel. Other rocks and riprap washed downstream have accumulated in the floor to a level about 2 feet above the invert of the box culvert. Numerous trees and brush are growing along the sides and bottom of the stream bed, especially on the east side slope where 24-inch and 30-inch diameter trees are growing.
